FAILURE ANALYSIS OF A GARAGE DOOR SPRING

AME 60646: Failure of Materials

Matt Landrigan

1 December, 2006

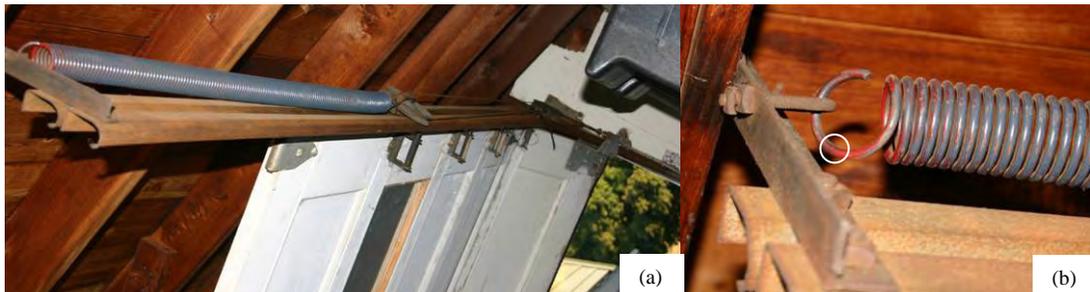
In May of 2006, an extension garage door spring fractured completely through rendering the door unusable until repair. A garage door operates with either two extension springs on either side of the bracket supports or one torsion spring across the top of the door frame. The motor for this particular setup drives a screw gear that pushes the door down when it closes putting tension into the spring (Fig. 1a). The springs are connected to a wire cable which runs over two pulleys redirecting the spring force along the curve of the door track. The springs aid the motor in lifting the door by placing an upward force on the door. The last coil of the spring is bent to form a hook (Fig. 1b).

Fig. 1. (a) Installed garage door extension spring in relaxed position. (b) View of operational spring with circle designating area of fracture.

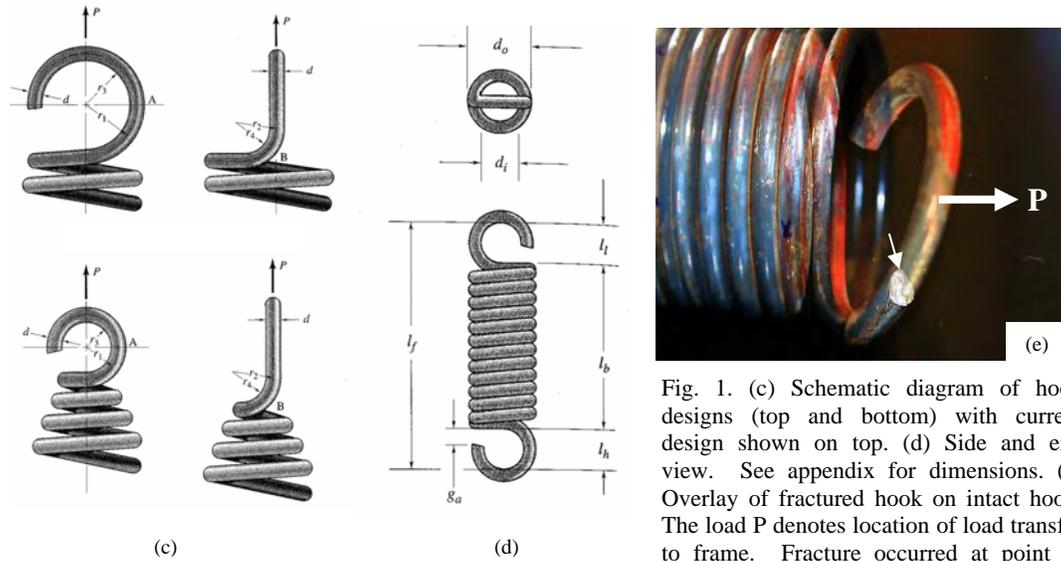
Fig. 1. (c) Schematic diagram of hook designs (top and bottom) with current design shown on top. (d) Side and end view. See appendix for dimensions. (e) Overlay of fractured hook on intact hook. The load P denotes location of load transfer to frame. Fracture occurred at point of maximum stress on inside of hook (arrow).

Most often helical extension springs fail at the hook and the design of the end hook impacts the stress concentration. This particular spring hook was manufactured by simply bending the last coil outward by 45 degrees. In idealized spring design, the end hook is bent outward forming a right angle with the plane of the previous coil. In the loading condition for this spring design the 45° angle causes a torque to act on the hook as well as the axial load (Fig. 1e). This was an important aspect used to determine the initiation region which will be discussed momentarily. Purely axial loading normally causes failure at the tensile edge furthest from the neutral axis. If a torque is added, the maximum stress shifts around the hook slightly due to the addition of the shear stress.

In reality, this part is very cheap to manufacture and currently retails for about \$15 at the local hardware store. Because it is likely that this spring has lasted at least 27 years, but more likely 54 years, it really would not be cost effective to improve the fatigue life. That being said, the easiest way to improve the fatigue life would be to put tighter manufacturing requirements to avoid tooling marks or other possible surface marks. Secondly, altering the wire material itself improves the fatigue life. Another way to increase the fatigue life is to reduce the stress in the spring hook. Reducing the moment arm (see Eq. 2) such as in Fig. 1c will drastically reduce the stress on the hook. These three aspects will increase the fidelity of the spring, but in this particular application it is not practical to spend the extra manufacturing time and money to improve the fatigue life.

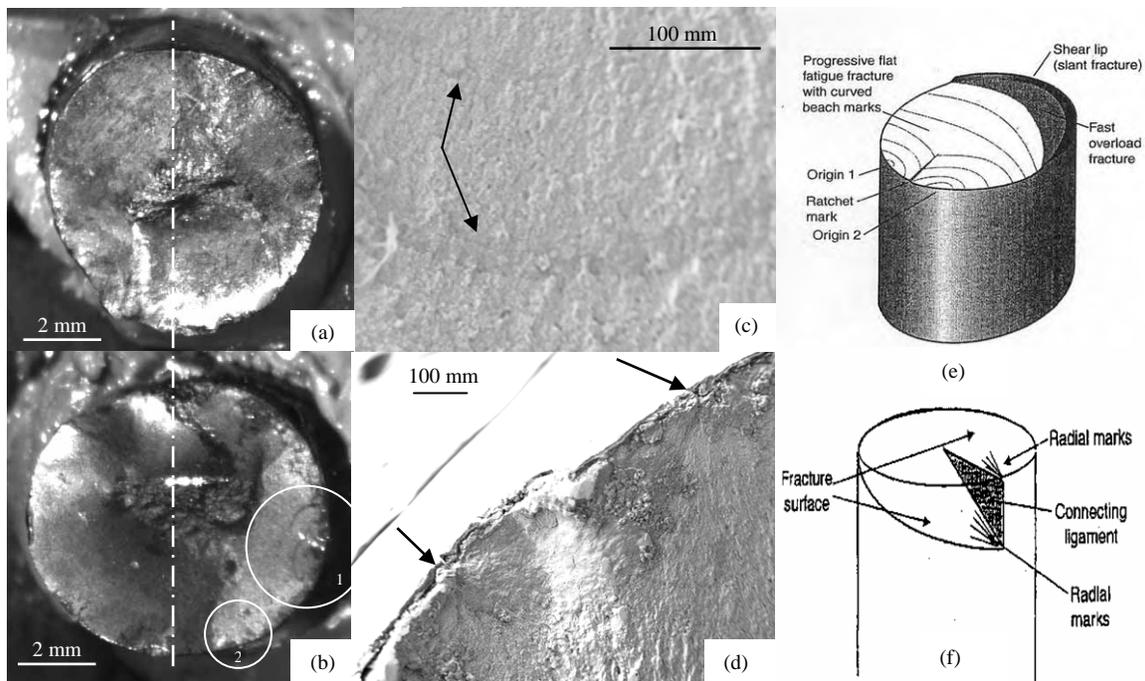
Both fracture surfaces were recovered and aided in the failure analysis. The surface proved to be quite complex with multiple modes of fracture indicative of the highly three dimensional surface (Fig. 2a-b). Areas of fatigue failure and brittle fracture exist. Observation under SEM revealed multiple crack initiation sites. The surface attached to the spring (Fig. 2a) was largely corroded with rust and therefore less visual information was available. The end attached to the hook proved invaluable because optical microscopy revealed rust bands on the inside of the hook – the area of maximum stress (Fig. 2b - circle 1). The rust rings follow two distinct centers (Fig. 2d, pointers) with radial marks leading outward from the centers. The rust rings are separated by a ratchet mark - a ledge between two initiation sites (Fig. 3c-d). Ratchet marks are indicative of initiation sites although it is normal to find beach marks around the marks (Fig. 2e) but there can be radial marks instead (Fig. 2f). As the crack planes propagate, the two planes come together forming a single fracture plane (Fig. 4c).

Inclusions, second phase particles, voids, machining marks or other surface flaws, and geometric anomalies are typical fatigue crack initiation points. Due to surface rust on the outside of the hook, a specific initiation type could not be determined. Because the initiation sites are at the surface, the cracks likely would have initiated because of a surface flaw such as a tooling mark or surface pit which could easily have been caused by corrosion.

Fig. 2. (a) Optical image of surface attached to spring and (b) surface of hook end. The right hand side was in tension. The white dashed line indicates neutral axis and the circle shows the region of initiation. (c) SEM image of rust bands. (d) SEM image of initiation points (pointers) surrounding ratchet mark (white region). Pictorial representations of ratchet marks and beach marks (e)⁷ and radial marks (f)⁸.

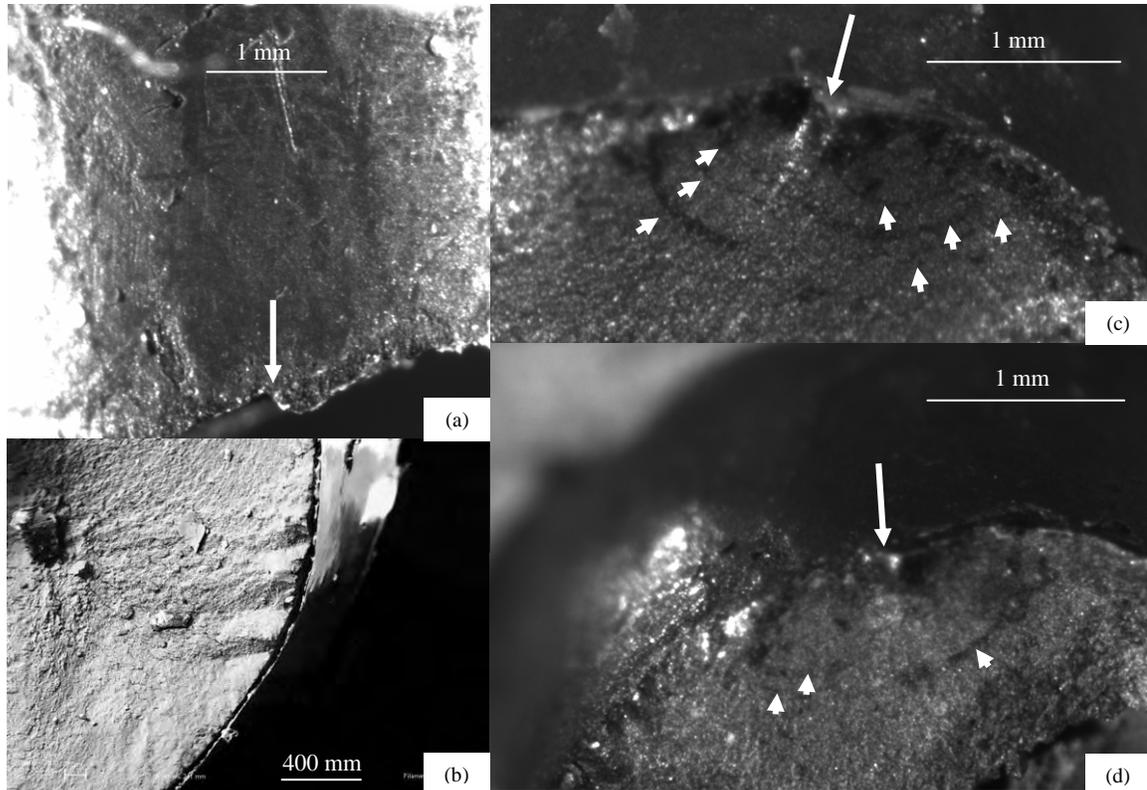
Fig. 3. Fatigue initiation sites. (a) Ratchet mark (arrow) around which rust rings formed. (b) SEM image of multiple ratchet marks from area 2 in Fig. 4b. (c) Fracture surface connected to hook end and (d) surface on spring end. Small markers indicate rust rings and large arrow points to ratchet mark.

The other area of interest is circle number 2 (Fig. 2b) where multiple ratchet marks can be seen under optical microscopy and closer under SEM (Fig. 3b). The location for the ratchet lines is understandable because the combined torque and tensile loading of the hook moves the maximum stress region around the outside of the hook closer to the neutral axis.

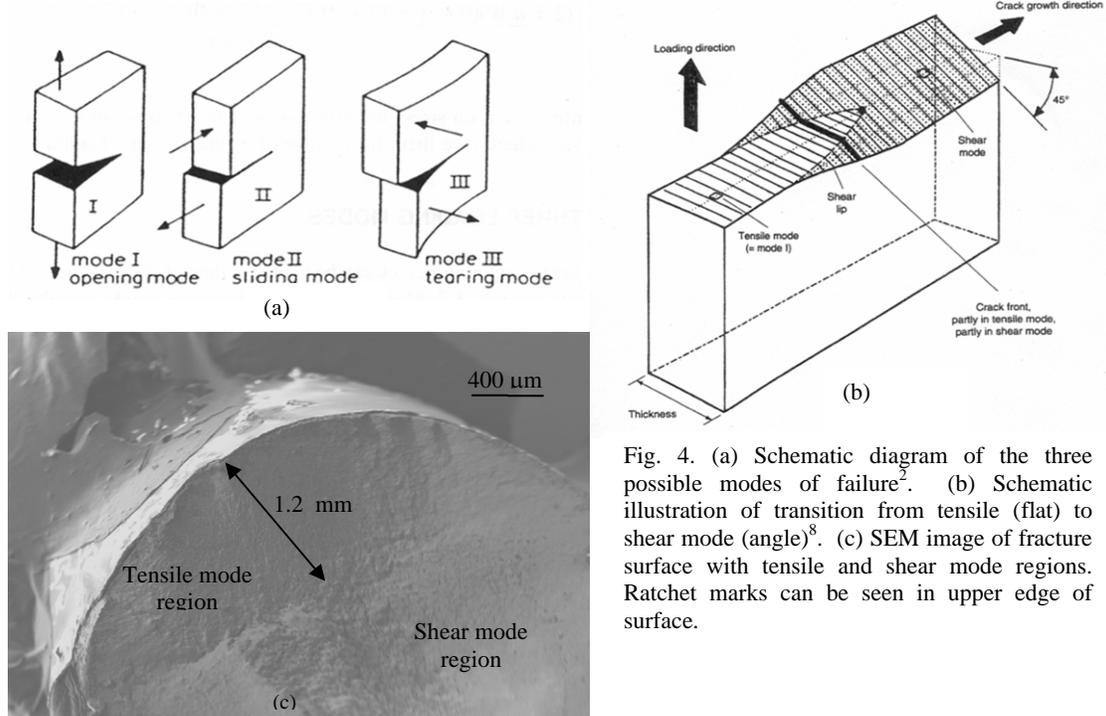
There are three different loading modes by which cracks can form and propagate as shown in Fig. 4a. Mode I is the tensile opening mode, Mode II is the in-plane shearing mode, and Mode III is the out-of-plane shearing mode². With the initiation sites in the tensile region of the hook (Fig. 4c) and the fracture surface perpendicular to the wire direction (Fig. 5), Mode I failure is responsible for the crack initiation.

There are two distinct regions of crack propagation. The presence of rust rings indicated that the crack propagated slowly and allowed time for corrosion to materialize. The fracture surface plane is perpendicular to the wire direction (Fig. 5) showing Mode I crack propagation initially. About one third of the way across the fracture surface (Fig. 4c), the crack switches to Mode II or possibly Mode III failure. The fracture plane switches directions on an angle called the shear lip as shown schematically in Fig. 4b and for this particular surface in Fig. 5. At the same time the crack propagated very quickly

Fig. 4. (a) Schematic diagram of the three possible modes of failure². (b) Schematic illustration of transition from tensile (flat) to shear mode (angle)⁸. (c) SEM image of fracture surface with tensile and shear mode regions. Ratchet marks can be seen in upper edge of surface.

because the fracture surface is rough in this region compared to the area around the rust rings indicating catastrophic failure occurred when the crack switched failure modes.

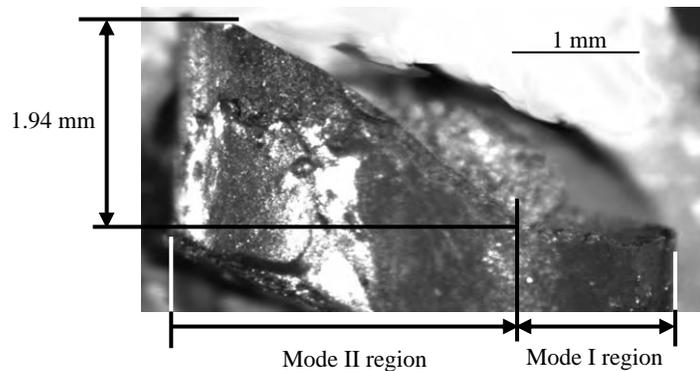
Fig. 5. Side view of fracture surface where Mode I and Mode II regions are visible.

Using the height of the shear region shown in Fig. 5 and Eq. 6 above, along with the hook stress calculated earlier gives a fracture toughness of $64 \text{ MPa}\sqrt{m}$. While this would indicate that the spring steel has a stronger fracture toughness than assumed earlier, it is close and therefore a reasonable approximation for the toughness of the spring steel.

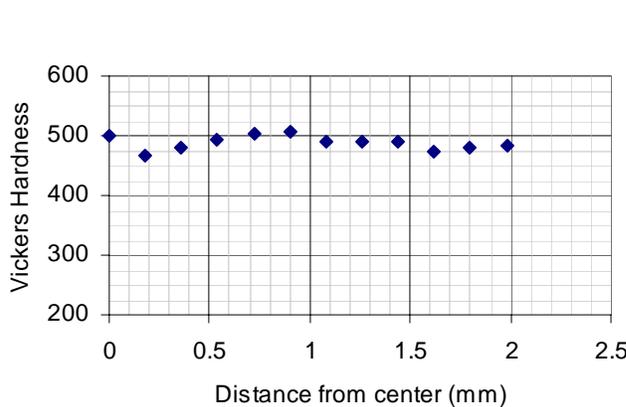
taken a few millimeters below the fracture surface on the spring side of the failure. The sample was embedded and polished to a one micrometer surface finish. The microhardness testing was performed with a one kilogram load for ten seconds. Hardness measurements taken from the center of the wire to the outside edge on the tensile side (Fig. 6) showed uniform strength throughout with an average Vickers hardness number of 488. Converting to Brinell hardness (HB) yields a hardness number of 459.¹⁰ Brinell hardness can be used to estimate the tensile strength (TS) of a material⁴:

This analysis proved very useful because of the lack of background information on the spring material. Using this correlation between the hardness and tensile strength resulted in a tensile strength of 1583 MPa. The standard extension spring stress recommendation for hard drawn steel wire (Fig. 7) of diameter 4.3 mm in light service is 780 MPa, half of the tensile strength. In addition, the range for class 1 hard drawn wire⁵ is 1360-1560 MPa and therefore, from a theoretical point of view, the spring was well within the design parameters for this application with similar properties to the hard-drawn steel alloy 4340.

Fig. 6. Results of Vickers Hardness test. Measurements were taken from the center and extending in the radial direction toward the region of maximum tension.

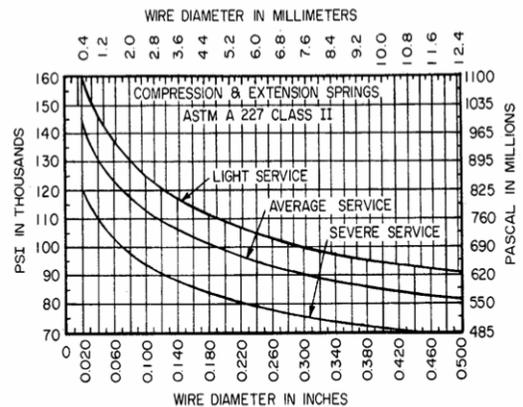
Fig. 7. Recommended design stresses for hard-drawn steel wire – based on ASTM A 227 for compression and extension springs¹.

transferring through the extension springs is less than the weight of the door. If the motor pulls up as little as 10% of the door weight, that reduces the stress to 790 MPa, essentially the same as recommended in Fig. 7. The motor likely pulls up even more because after the spring failed, the door was lifted a couple of times with only one operational spring and the motor.

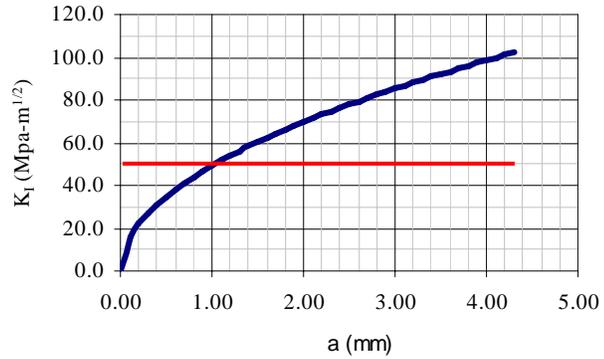
where σ is the far-field stress and a is the crack length. The fracture toughness, K_{IC} , for Steel Alloy 4340 is $50 \text{ MPa}\sqrt{m}$. Under the hook stress calculated in Eq. 3 and a K_{IC} of $50 \text{ MPa}\sqrt{m}$, the critical crack length to induce catastrophic failure is 1.03 mm (Fig. 8). It should be noted that the Mode I region of failure (Fig. 4c) has a depth of 1.2 mm. Although this isn't exactly the same length, they are on the same order indicating that the fracture toughness estimate is a good approximation.

Fig. 8. The effect of the flaw size on the fracture toughness, K_I using the stress from Eq. 3. K_{IC} approximation is in grey.
