FAILURE ANALYSIS OF BRASS HOSE DIVERTER

JACKIE GARRISON
FAILURE MECHANICS

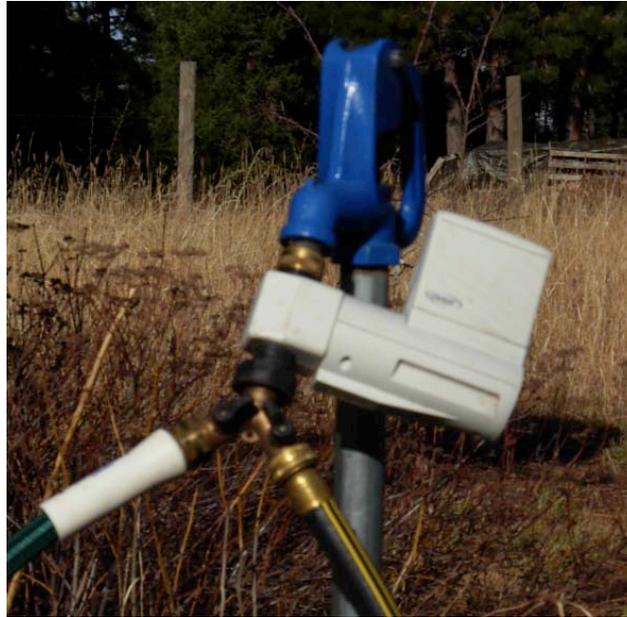
The brass hose fitting was purchased in 2005 to divert water from a bury hydrant to two different hoses (each approximately 50 feet long) to water the grass (Fig. 1). The diverter was approximately -45° from horizontal. The hose fitting was used during the spring through fall and stored below the cabin during the winter months to avoid freeze-thaw cycles. Recently, the grass was fertilized with Scott's® Feed and Seed. The water was pumped from a well approximately 40 feet below the surface.

Figure 1: Brass hose diverter in its original configuration prior to failure. It was connected to a timer (which is connected to a bury hydrant) and two hoses.

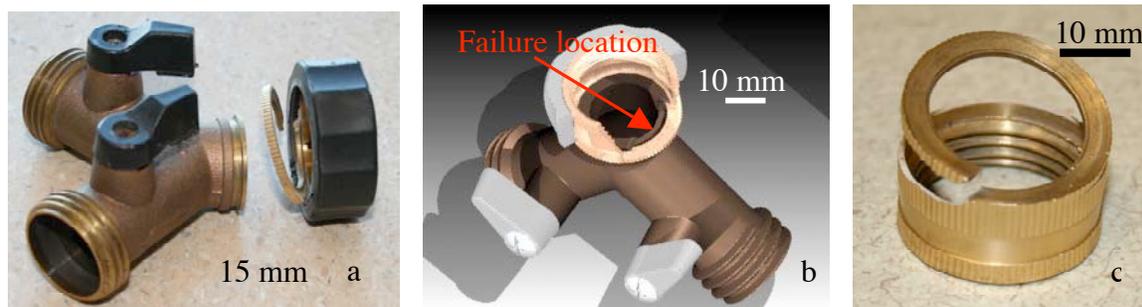
On the day of failure in late September, the brass fitting was being unscrewed by hand after being on the bury hydrant since June, where it was also screwed on by hand. The interlock connecting the female threaded portion to the Y-portion of the diverter failed and the inner threads at the base of the diverter subsequently failed, pulling away from the rest of the diverter (Fig. 2).

Figure 2: a) Failed brass hose diverter at the base of the Y-configuration at the first thread, b) reconstructed solid model of intact diverter with a cut-away section of failure location, c) location of failed threading.

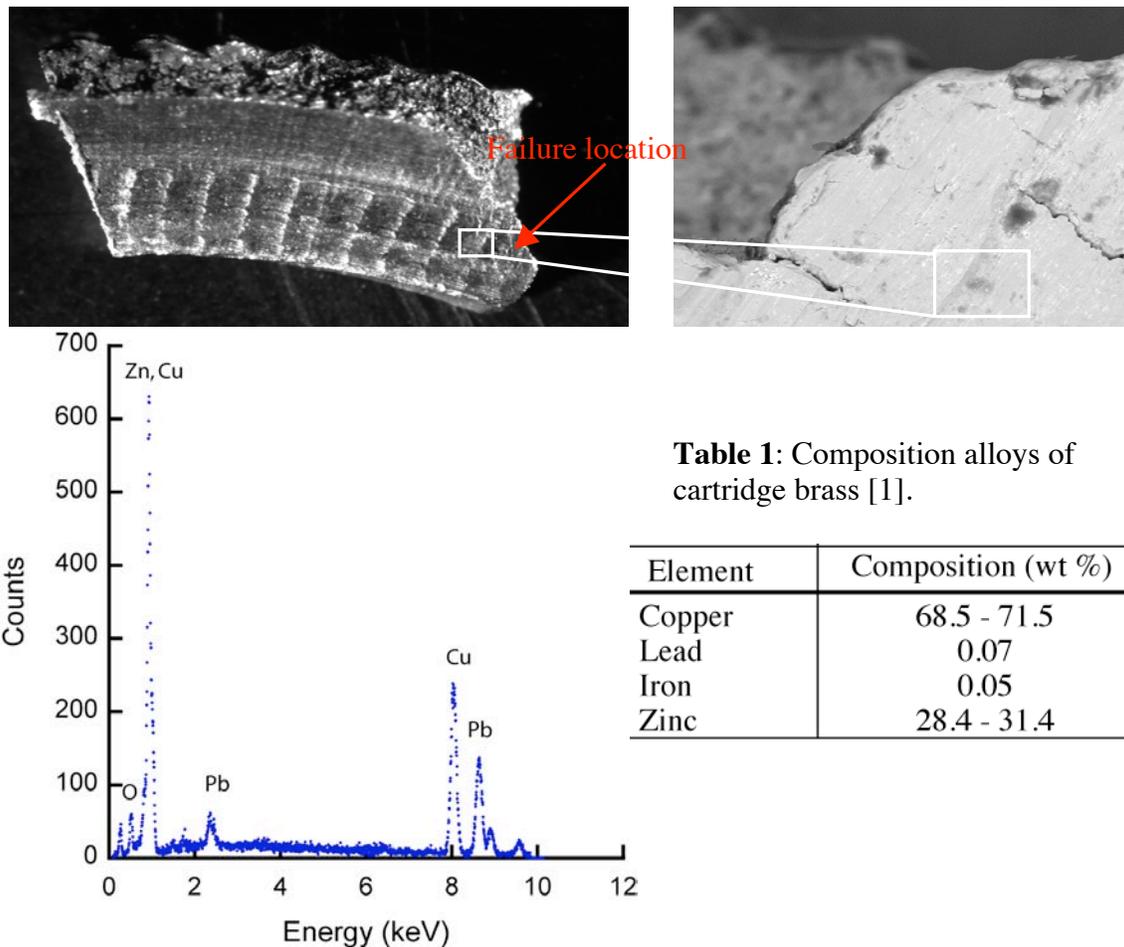
Because the manufacturer of the part was unknown, the diverter was assumed to consist of cartridge brass because this material is used for most plumbing applications [3]. To verify the assumption, an unpolished surface of the specimen free of cracks was subject to Energy Dispersive X-ray Spectroscopy (EDS) (Fig. 3). EDS indicated levels of copper, zinc, and lead, which is characteristic in cartridge brass (Table 1). The oxygen could be from an oxide layer or an artifact from the SEM.

Figure 3: a) Optical microscope image of surface near the fracture site and fracture surface (within the plane the view), where the white box indicating location of EDS of non-fractured brass, b) higher magnification of failure surface and corresponding EDS location, c) EDS results for brass within the white box in a) and b), verifying the material is cartridge brass.

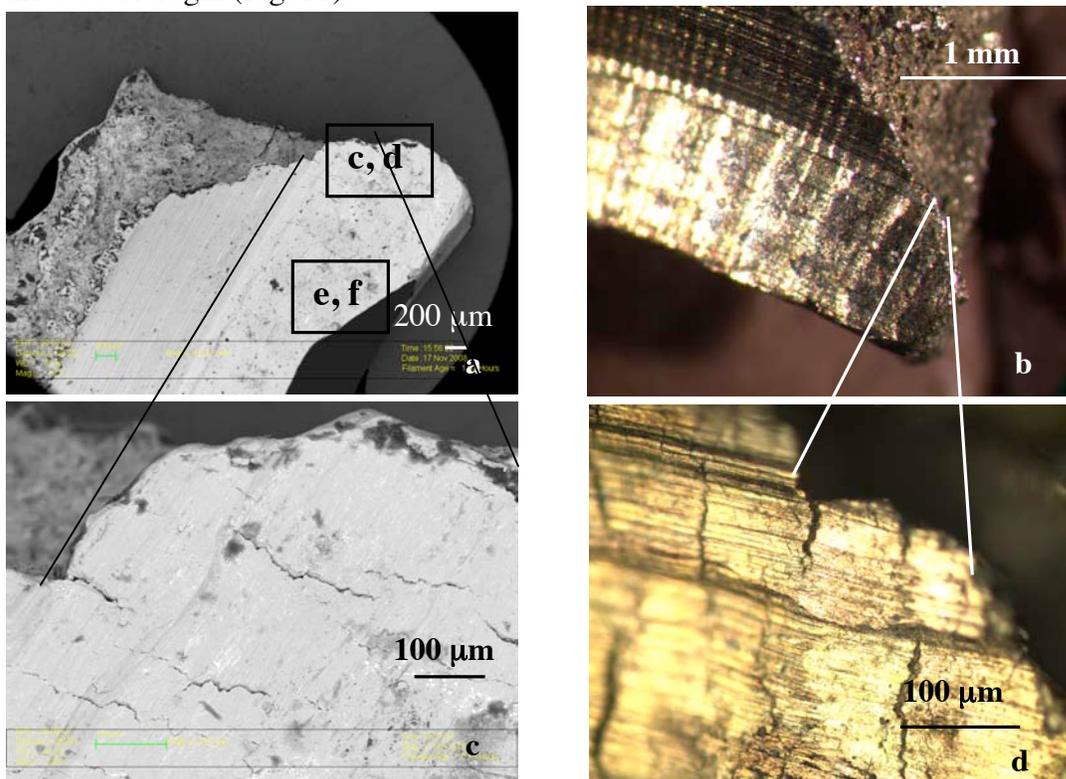
Ammonia can cause a distinctive brittle appearance that is associated with SCC, where the cracks are highly localized because the rate of corrosion is low [4]. This localized area of corrosion can be the result of intergranular attack, pitting, or surface flaws [4]. In many cases, SCC occurs where there is little visible evidence that the surface was corroded [5]. In the case of the diverter, the cracks can be seen in a highly localized area near the fracture surface (Fig. 4) and less than 1 mm away, the surface is virtually free of cracks (Fig. 5a). In addition, the diverter also has threads that run along the inner diameter, and under higher magnification, reveal serrated radial tick marks that could be considered a surface flaw that expose the brass to environmental conditions and allows the SCC to begin (Fig. 5b).

Figure 4: a) SEM image and b) optical microscope images of surface near failure site showing where higher magnification images were taken, c) SEM image and d) optical microscope image under higher magnification of highly localized brittle SCC.

Because cartridge brass is susceptible to stress corrosion cracking in an ammoniacal environment, the use of fertilizer with ammonia may have been the cause of failure. SEM images show brittle fracture beginning at a surface flaw with subsequent ductile failure through the thickness of the diverter, which is indicative of SCC-initiated fracture. The fracture occurs when the ammonia, in the presence of moisture and oxygen, forms an oxide layer on the brass. Because the oxide layer is inherently brittle and formed on a surface flaw, crack initiation began at the greatest stress concentration and propagated through the layer until it was blunted by the unaffected ductile brass. This brass was then exposed to the ammoniacal environment and the process repeats itself. Predicting the failure due to SCC requires knowledge of the stress state and the material properties of the brass. This ductile behavior caused LEFM to over-predict failure. The role of SCC was not included in those calculations. But previous experiments using J-integrals were used to provide a basis for understanding the material's critical resistance to crack propagation.

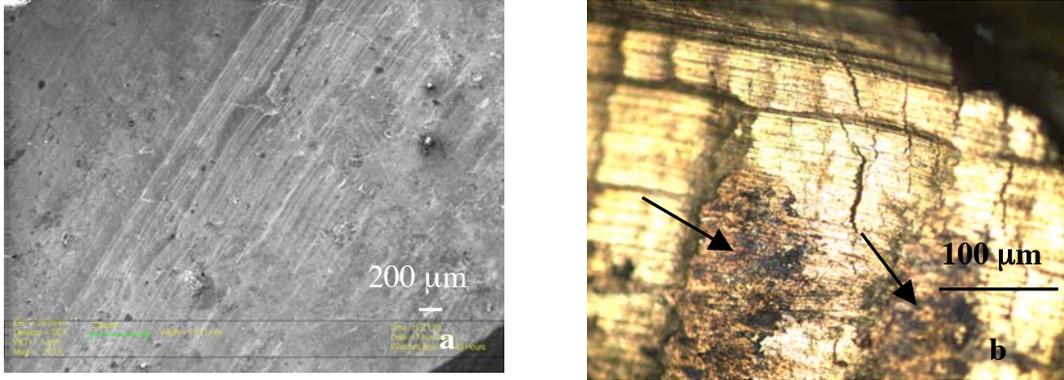
Figure 5: a) higher magnification image showing a virtually crack-free surface less than 1 mm away from the SCC region and b) optical microscope image of surface flaws from serrated radial tick marks that may have been crack initiation site.

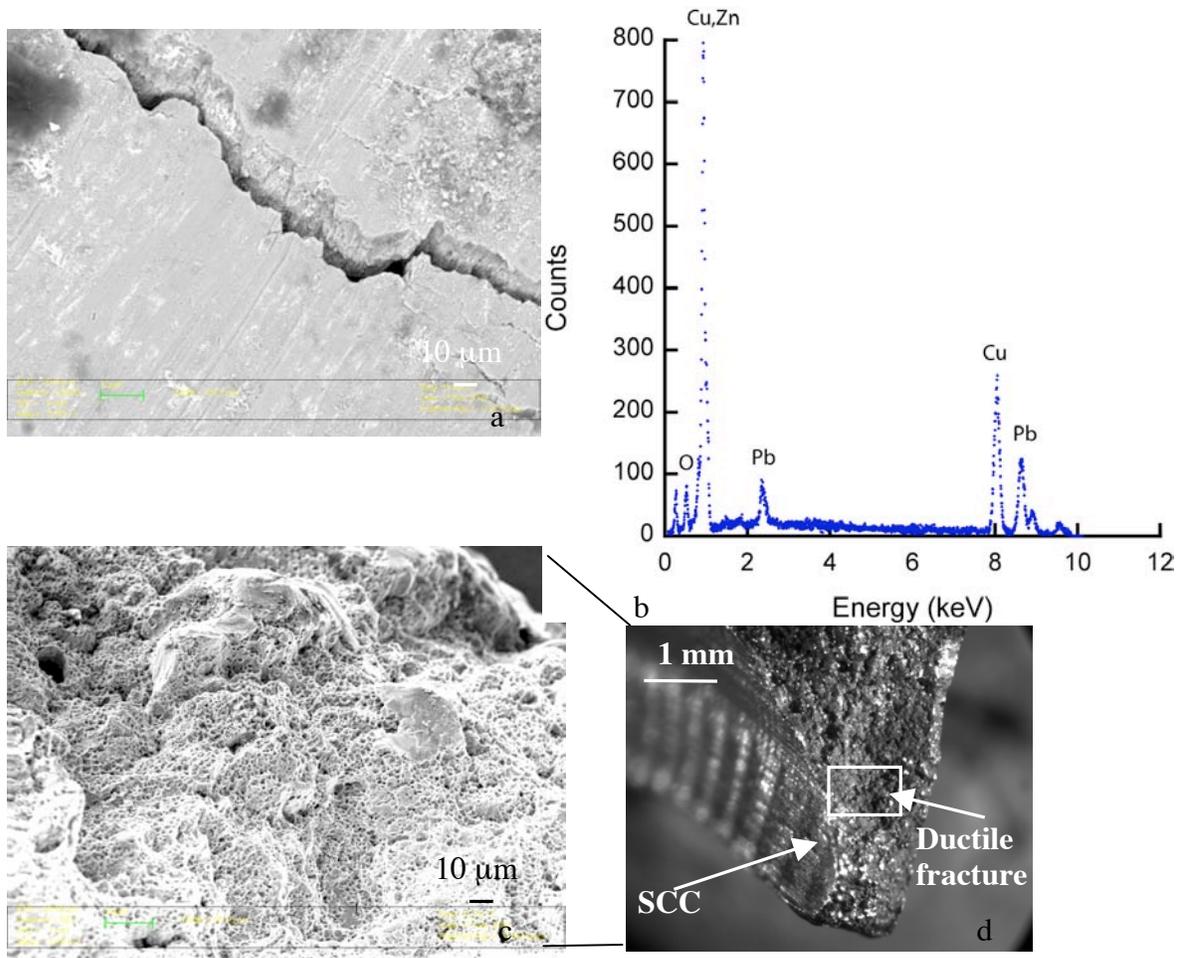
The presence of ammonia in oxygenated solutions can lead to SCC, which causes brittle cracking of an otherwise ductile material. Moisture films on metal surfaces will dissolve significant amounts of ammonia, even at low concentrations [3]. The ammonia, in the presence of oxygen and moisture, causes a film (oxide layer) to form on the surface of the walls [6]. The reaction for this can be found in Appendix A. The high stress concentration that results at the crack tip from inherent oxide tensile stresses causes this protective oxide layer to rupture locally, exposing the underlying surface to the ammonia and the dissolution of copper begins [5]. This is called film-induced cracking [7]. This phenomena occurred in the diverter, where brittle cracks were exposed on the surface due to corrosion and propagated in a ductile manner through the thickness of the specimen, which was originally unaffected by corrosion but was subject to the stress concentration of the initial crack (Fig. 6a). Because the underlying thickness showed microvoid coalescence, the fracture happened rapidly enough because the corrosion behavior was only identified near the surface. This ductile failure is evident because of the necking behavior of the microvoids that coalesced in the presence of a high tensile stress from the untightening of the threads at the based of the diverter [5] (Fig. 6b).

Ammonia was present in the water system by use of a Scott's® Feed and Seed, a fertilizer used to promote denser grass growth [8]. The fertilizer was derived from ammoniacal phosphate and contains 5% ammoniacal nitrogen. Although the percentage of ammoniacal constituents within the lawn is unknown, low concentrations of ammonia are needed to create SCC if the stress conditions are high or if surface flaws are present [4].

Figure 6: a) SEM image of high magnification crack caused by ammoniacal environment, b) EDS of crack surface, c) SEM image of ductile fracture, represented by coalesced microvoids that have a rim around their edges (similar to necking), d) optical microscope image of location of ductile fracture on failure surface.

In order to reduce the likelihood that SCC does not occur in a similar brass diverter, the easiest change would be to use a different fertilizer that does not include ammonia. Another (more expensive) option could be to use a deeper water source so that the ammonia within the water from the fertilizer is perhaps more diluted, although only low concentrations are needed to cause SCC with the right stress states and environmental conditions. Because brass is consistently used throughout the plumbing industry, different types of surface finishes and alloying components are used to avoid stress corrosion cracking. Studies have shown that using copper alloys that contain phosphorus, arsenic, magnesium, tellurium, tin, beryllium, and silicon decreases the probability of cracking [3]. Decreasing the zinc content is also thought to make the alloy more resistant to SCC [3].

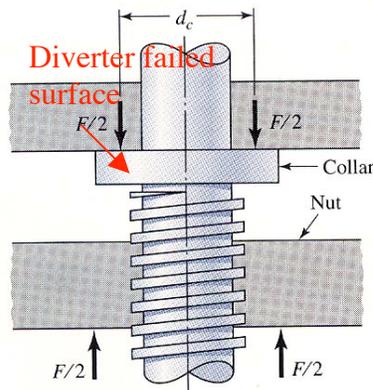
Unscrewing of the diverter from the water source resulted in external forces being applied to the surface where cracks had initiated. To find the force induced by the torque of unscrewing (which was estimate to be no more than 8 N-m), the brass was treated as a thrust collar with the failure surface as the base of the collar (Fig. 7). The torque applied and the resulting stresses of the diverter force are related by [11]:

Figure 7: Diagram of forces during tightening on a collar (equal but tensile during untightening).

This result indicates that the stresses do not exceed the yield stress of 90 MPa. In addition, including the stresses due to internal pressure from the water results in negligible forces. As a result, 90 MPa will be used for any fracture mechanics analysis.

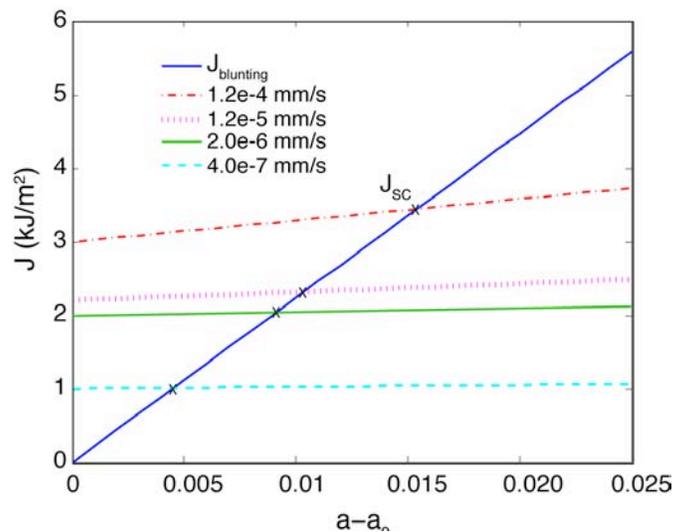
al [1] for specimens pre-cracked in fatigue and then exposed to an electrolyte to simulate stress corrosion cracking, a J_{SC} value was found at 4 different crack growth rates (Fig. 8).

The values of J_{SC} decreased with decreasing rates of deformation, indicating that the resistance to stress corrosion crack growth is generally reduced when the specimens are strained slowly. This may show that the diffusion of the corrosive environment cannot diffuse to the crack tip before the ductile material blunts the crack. When the deformation rate is slower, the diffusion process has more time to occur after the oxide layer has initially cracked, which will expose more copper to the ammoniacal environment and lead to more cracking. In relation to the diverter, Figure 4c shows a SCC crack approximately 0.2 mm long that has not propagated to failure. If we assume a slow deformation rate and the current crack is the initial crack length, then the critical length is 0.215 mm, indicating the sensitivity of the material to stress corrosion cracking and its relationship to failure when exposed to an electrolytic environment like ammonia. This also assumes that the crack length will propagate through the oxide layer and not be blunted by the ductile brass. The calculated values may be a good representation for approximation of fracture toughness.

Figure 8: Crack growth resistance curves at small crack extensions with different rates of deformation. The blunting line was calculated based on equation (8) and the empirical data was adapted from [1].
